AD 2008-13-17

Circuit breaker-type switch replacement

Update 8/21/2008

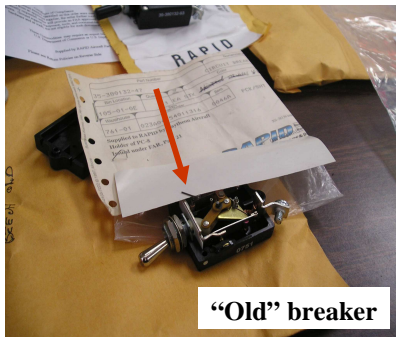
“Old” breaker

This unused, original Beech part circuit breaker is of the type required to be replaced under the AD. Note the straight end of the spring, indicated by the red arrow. According to Beech technical support and breaker manufacturer Tyco Electronics, the end of this spring scratches insulative material inside the breaker when the switch is cycled, and as the aircraft subpanel vibrates in flight. Eventually, they say, the spring will wear through the insulation, creating the alternative electrical path that leads to overheating and the potential for fire.

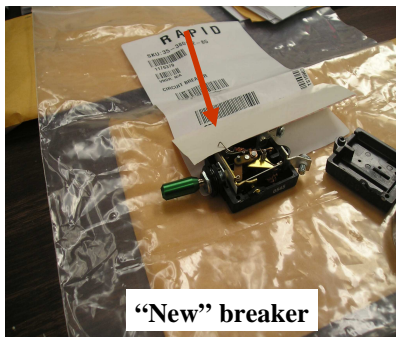
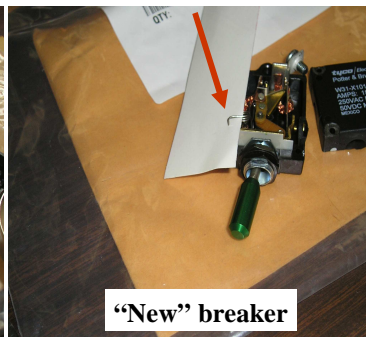
“New” breaker

ABS purchased two new breakers from RAPID (two different Beech parts numbers) of the type called out as replacements in the AD. We discovered the spring in each of these parts is bent so that it does not rub against the inside of the breaker when the switch vibrates or is turned on and off.

Tyco says this modification eliminates the failure mode that caused FAA’s concern, and the new-design breaker has been tested to 50,000 cycles without failure.

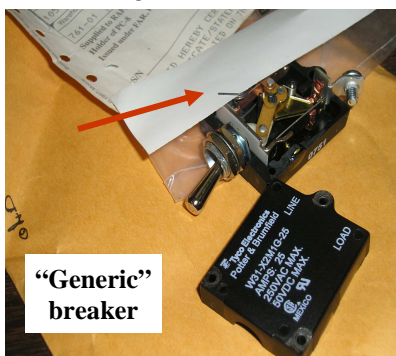
“Generic” breaker

ABS also purchased a new Tyco breaker from an aircraft parts supply house that carries the same Tyco part number as the Beech part, but does not have the additional Beech part number or the color-coded switch handle that Tyco adds to parts it supplies to RAPID. Note this new, “generic” circuit breaker does *not* have the modified spring design. According to Tyco, parts without the Beech part number do *not* address the failure modes that led to AD 2008-13-17 even though they share a common Tyco W31-series part number.

Consequently, ABS recommends that, if you have a circuit breaker-type switch that gets hot to the touch in operation, that generates smoke in the cockpit, that continually pops under a load, or that you replace to comply with AD 2008-13-17 or for any other reason, that you **only use Beech part number breakers purchased through RAPID** to ensure you have the new-design spring. Note that only Beech part number breakers are called out as AD replacements.
